IMPORTANT SAFETY NOTICE

SUBJECT: RIDGID® ProPress XL and R2 Press Rings, sizes 2 $\frac{1}{2}$ ", 3" and 4", sold individually and as a part of kits through August 10, 2007:

August 31, 2007

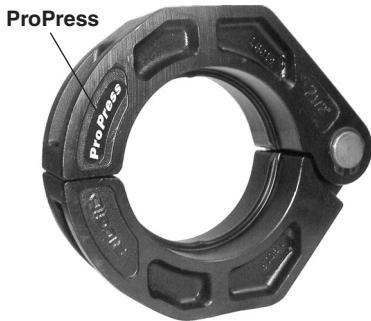
ProPress XL Press Ring
(No Strap, Needs Strap Retrofit)

This is a Product Recall Notice. Ridge Tool recently determined that the hinge area of some of these rings could break and allow part of the ring to strike a user or others which could result in **serious personal injury**.

All of the above listed products sold before August 10, 2007 may exhibit this problem. Affected units can be identified by the catalog number on the packaging, and by the words "ProPress" or "R2" on the ring as shown in the above photos. Any ring sold after August 10, 2007 includes the strap shown, and is not subject to this recall. This recall does not apply to rings marked "ProPress XL-C"

Please take immediate steps to determine if you have any of these products in your possession. Do not use these rings until they have been retrofitted. Contact Ridge Tool Technical Services at (800) 519-3456 or TechServices@ridgid.com. Ridge Tool will provide parts and instructions to retrofit the rings to prevent separation in the event that the hinge area breaks.

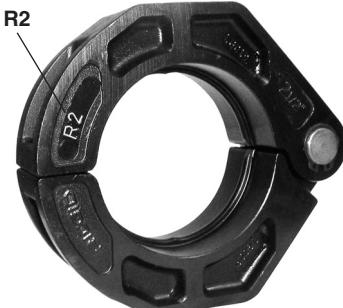
R2 Press Ring
(No Strap, Needs Strap Retrofit)

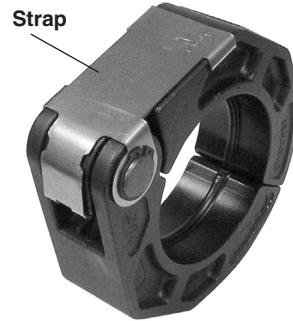
Ring with Strap –
(Correct No Action Required)
